BANK EROSION STUDY

Ohio River Division Field
OHIO RIVER BANK
EROSION STUDY.

OHIO RIVER
BANK EROSION STUDY

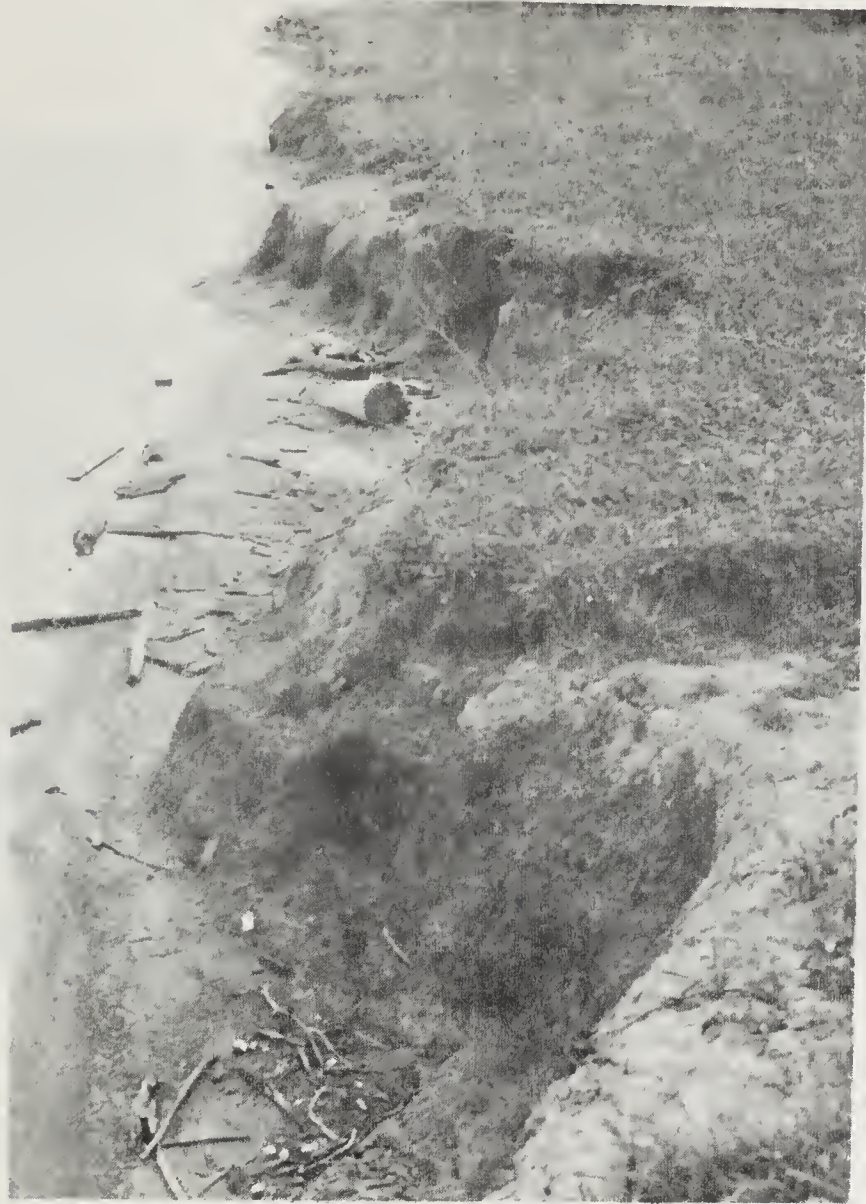
C

Lower bank and grass-covered terrace.
2 May 1977

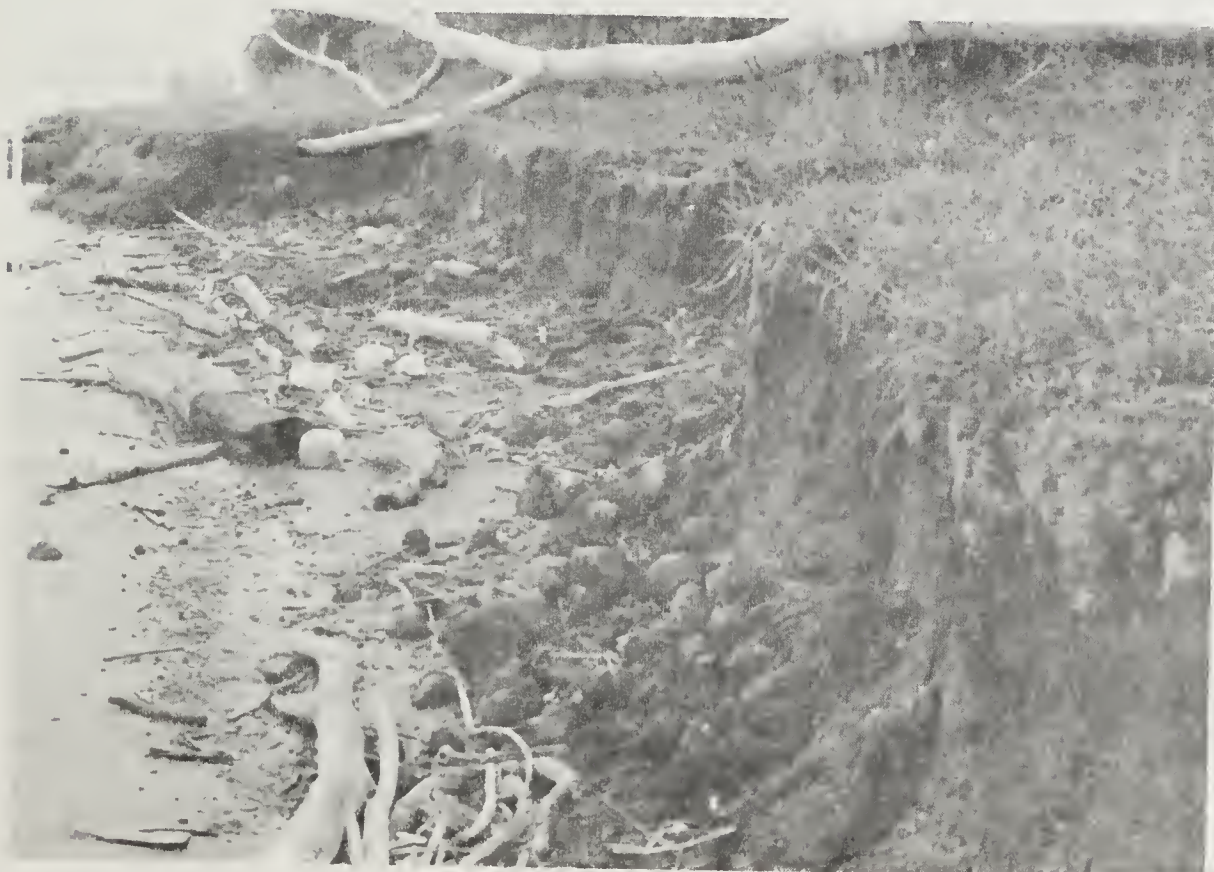
D

Toe of bank. Note buried limb of tree.
2 May 1977

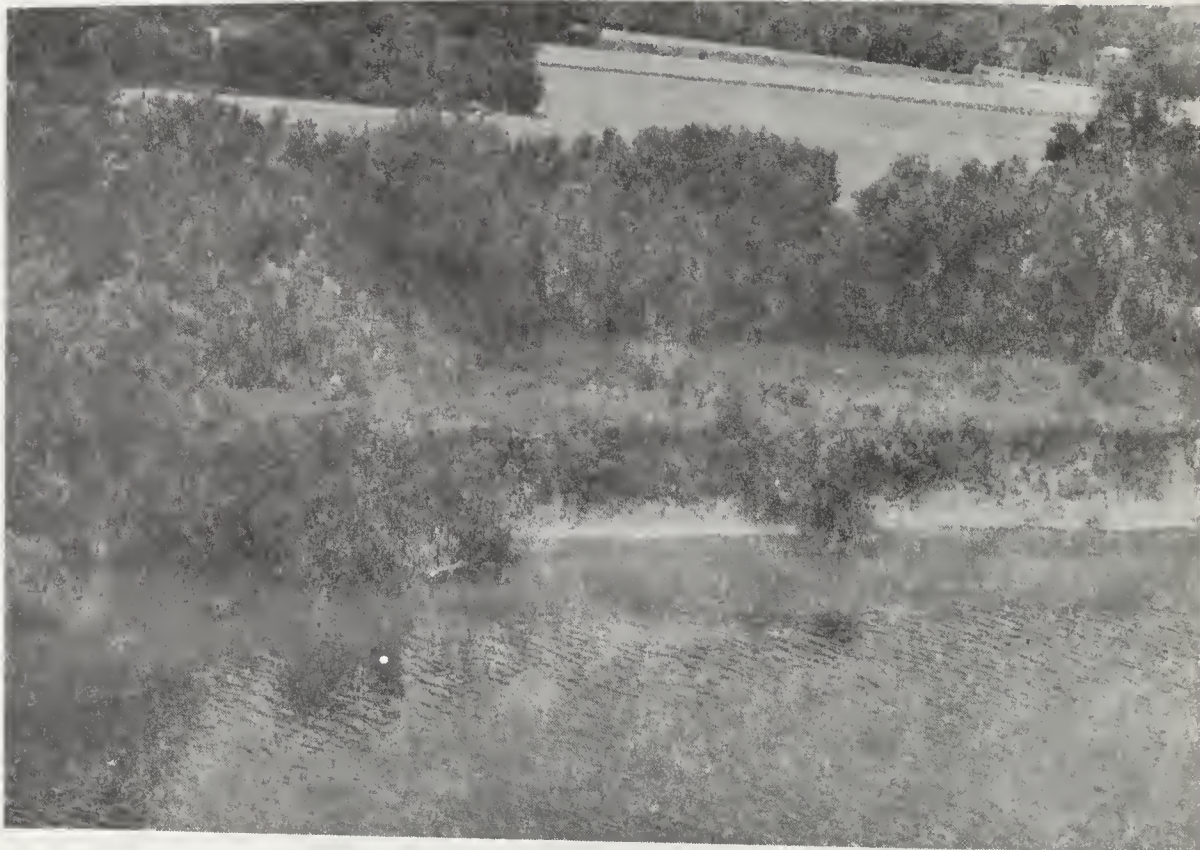
A

Approximate mid-point of property. Tree line follows Little Poison Creek. Past marks wave measurement station. 23 May 1977

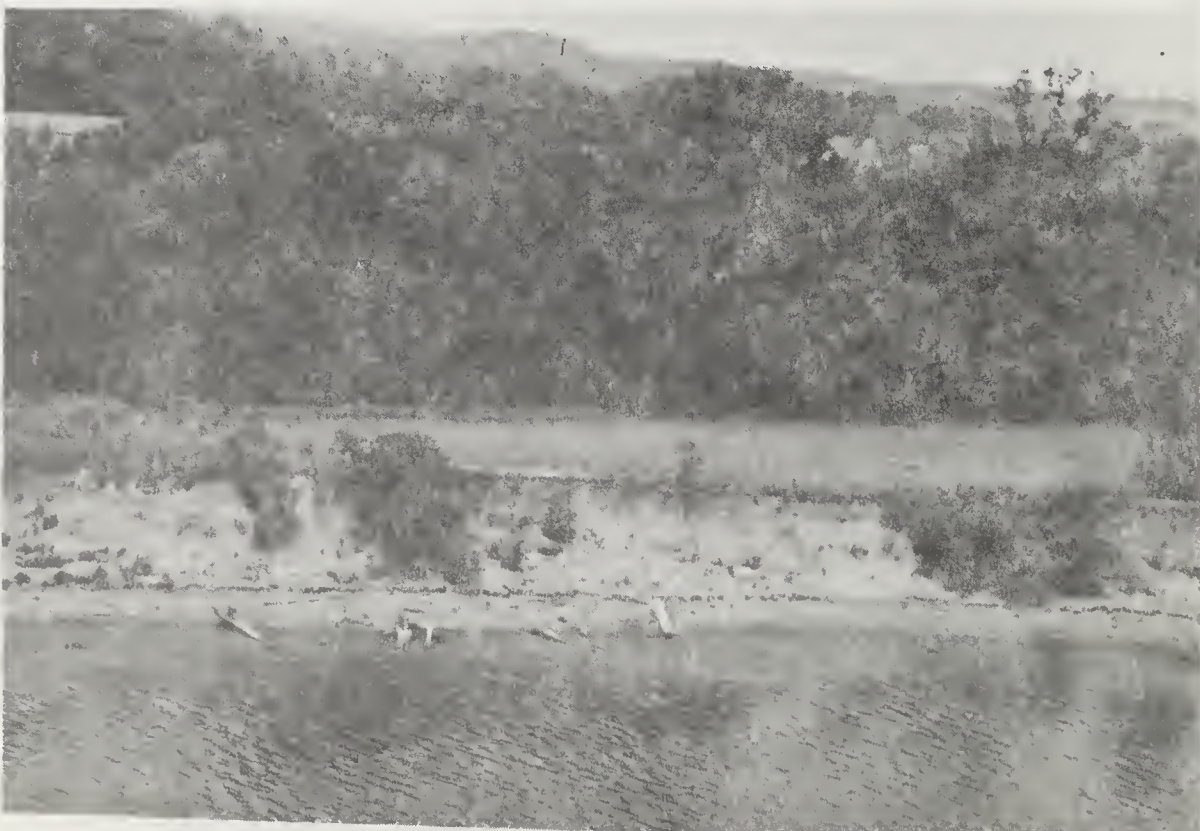
B

Approximate upstream limit of property.
23 May 1977

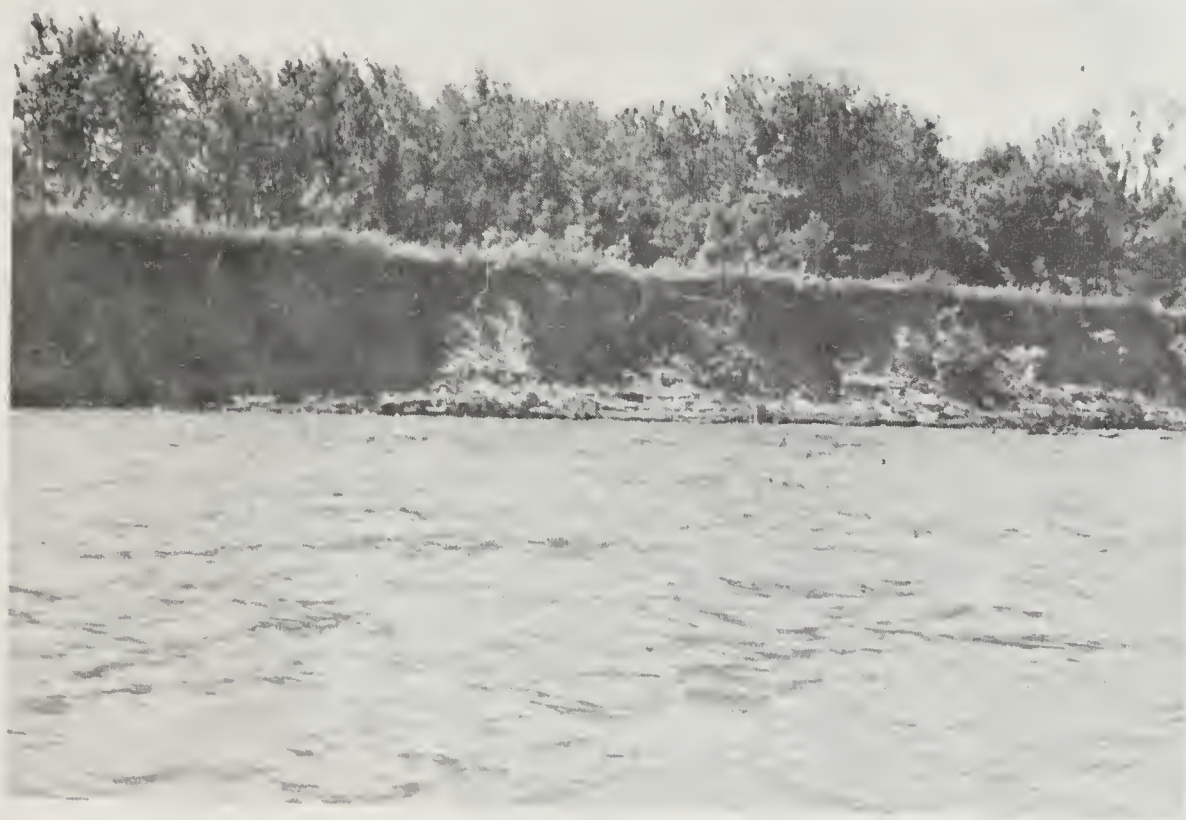
C

Sampling location
4 May 1977

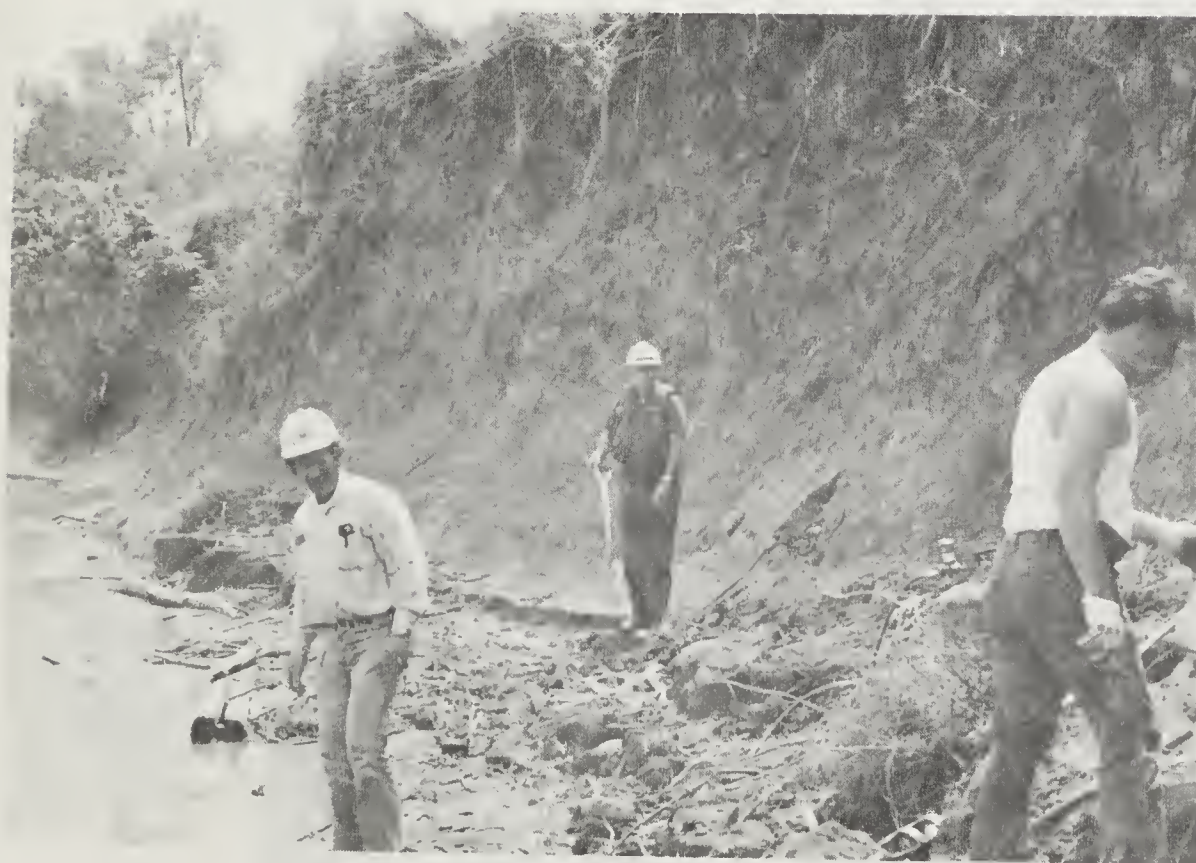
D

Looking downstream from sampling location.
4 May 1977

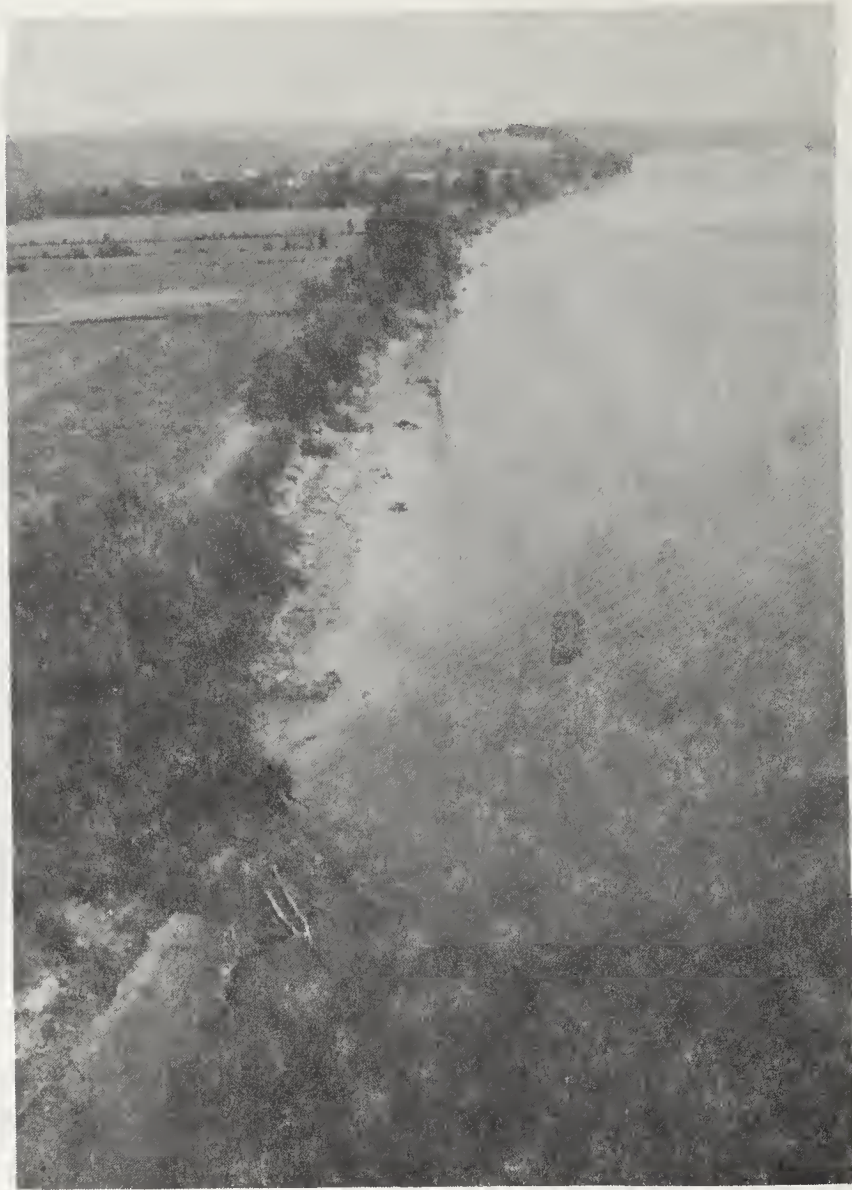
A

General view of Glenn property
looking upstream. 23 May 1977

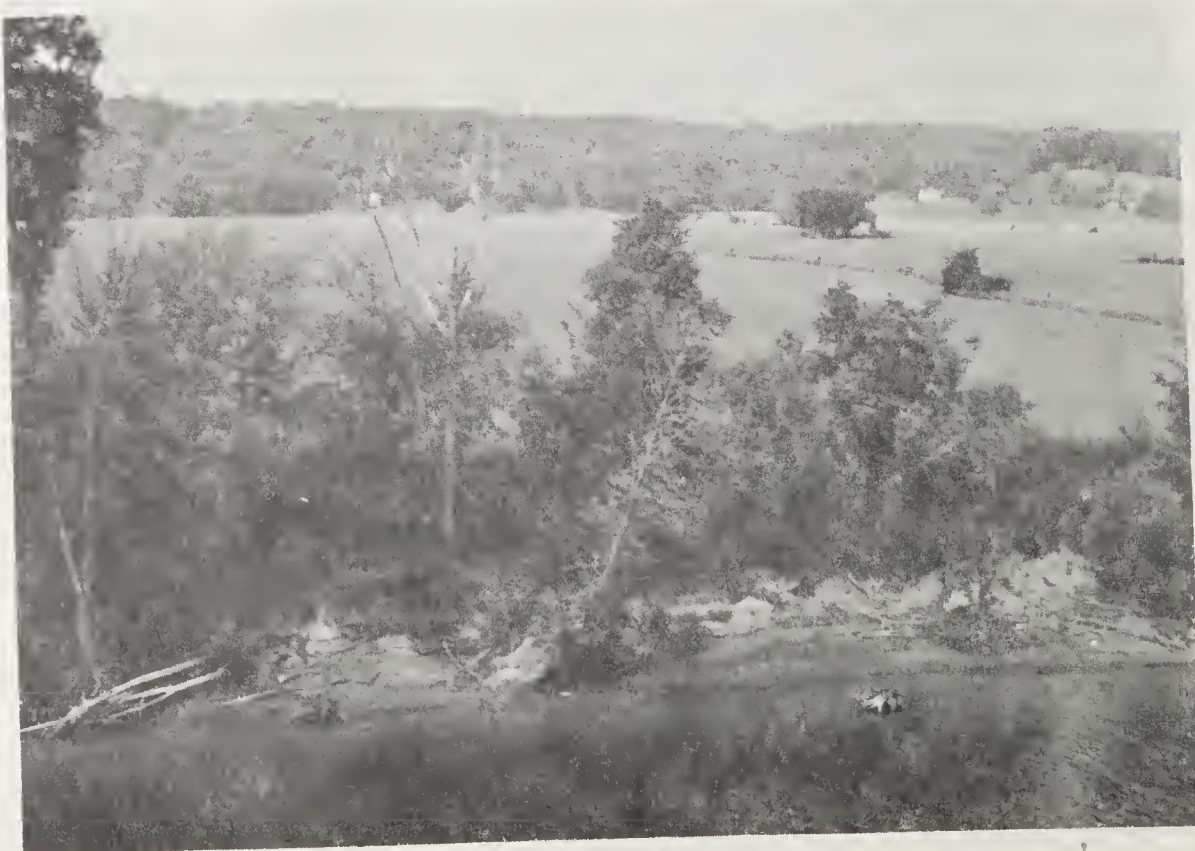
B

Bank area showing recent erosion and apparent scour
areas. 23 May 1977

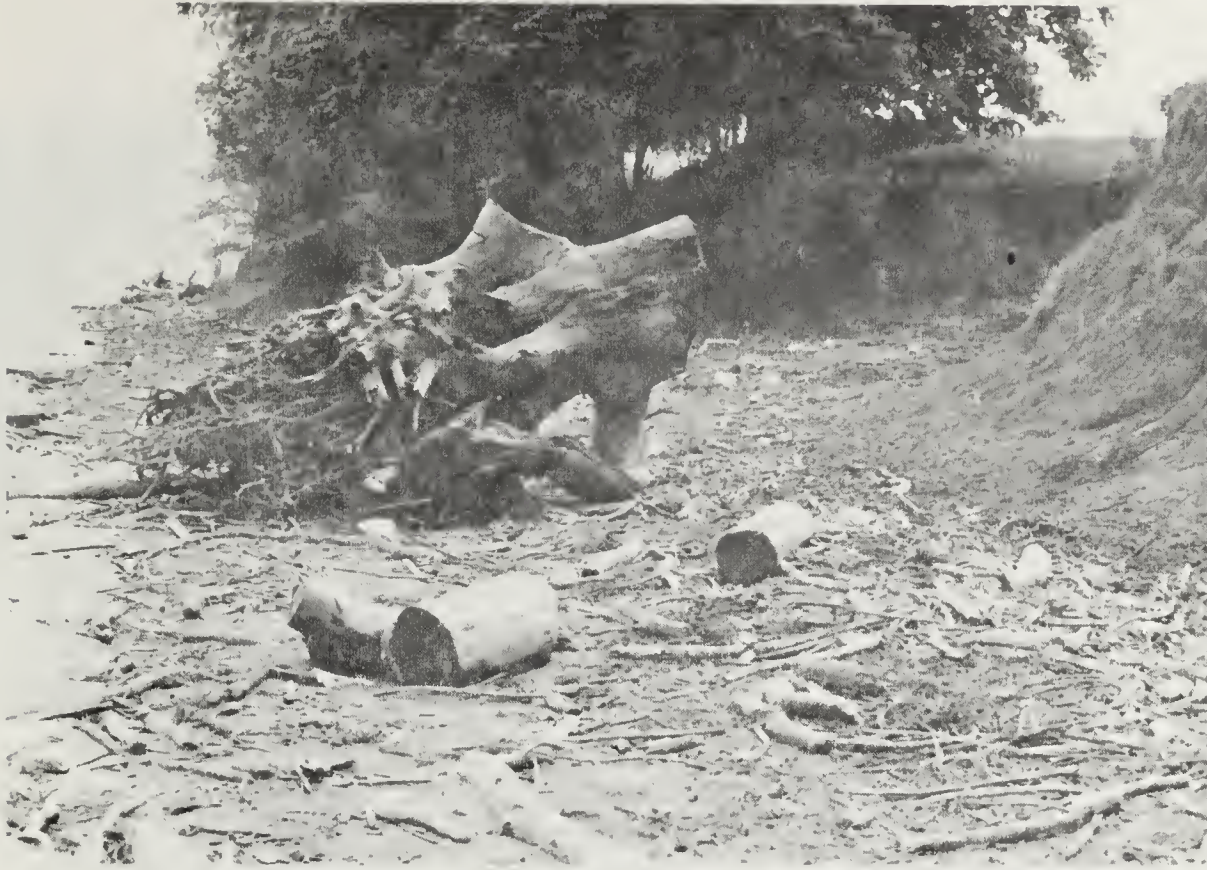
C

Apparent scour area in bank downstream of large
inplace stump. 5 May 1977

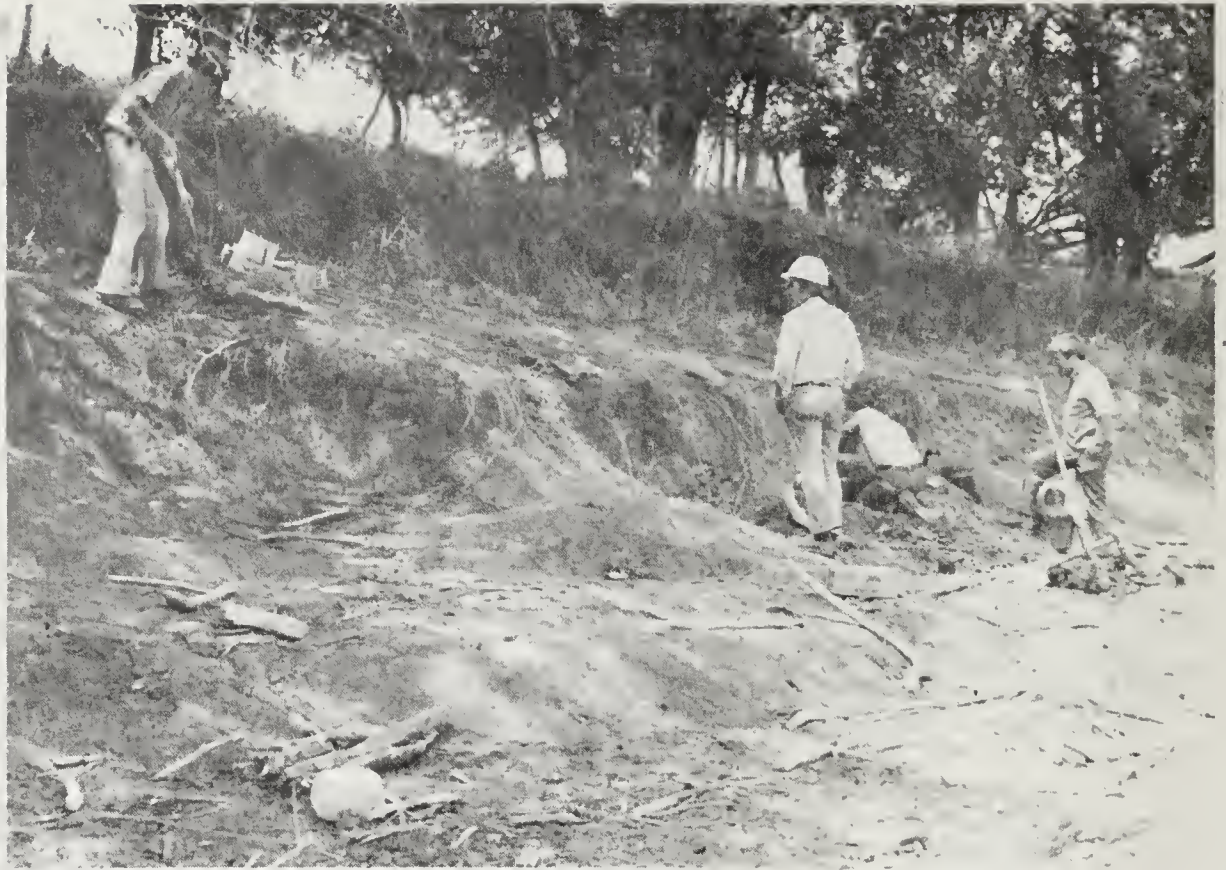
E

Sampling site located within the central portion of
Glenn property. 5 May 1977

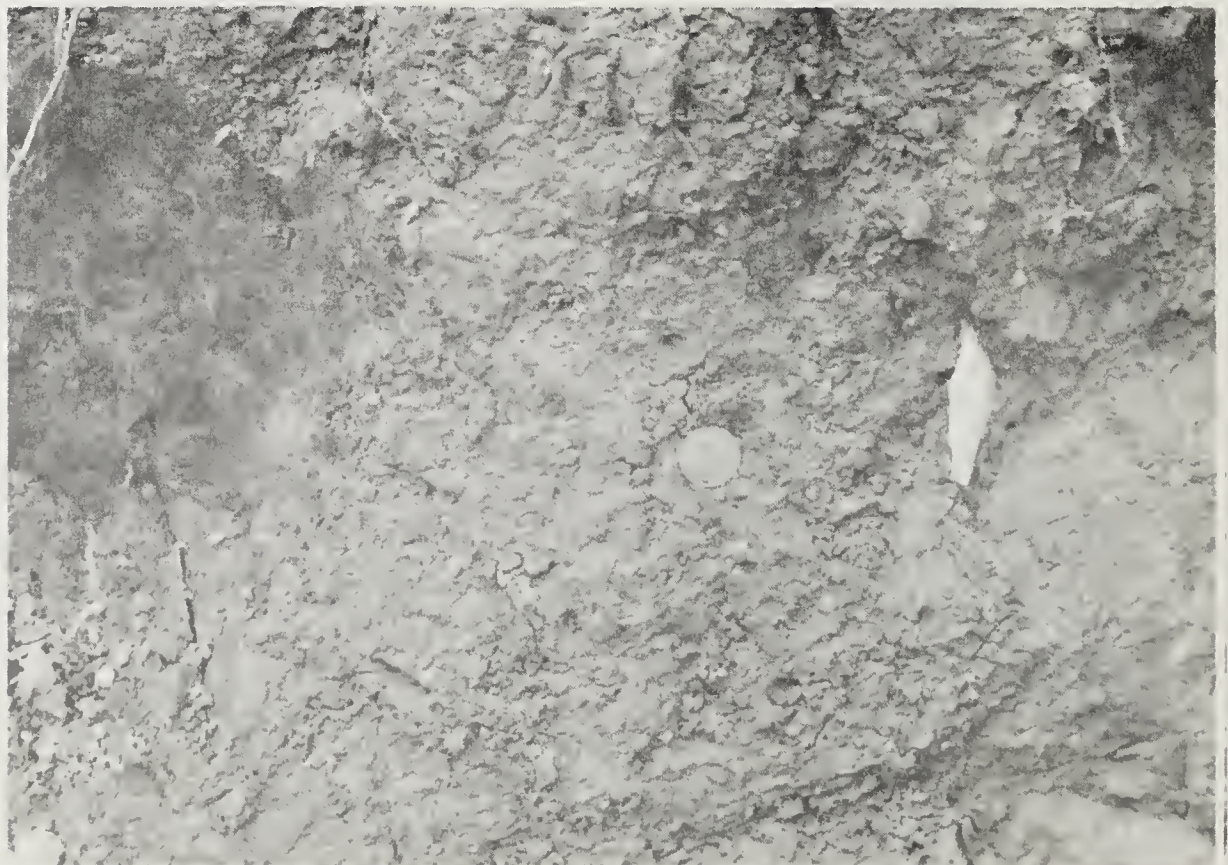
F

Worked flint in-situ at depth of 16.4' below top of
bank near sampling site. Excavated bank at left.
5 May 1977

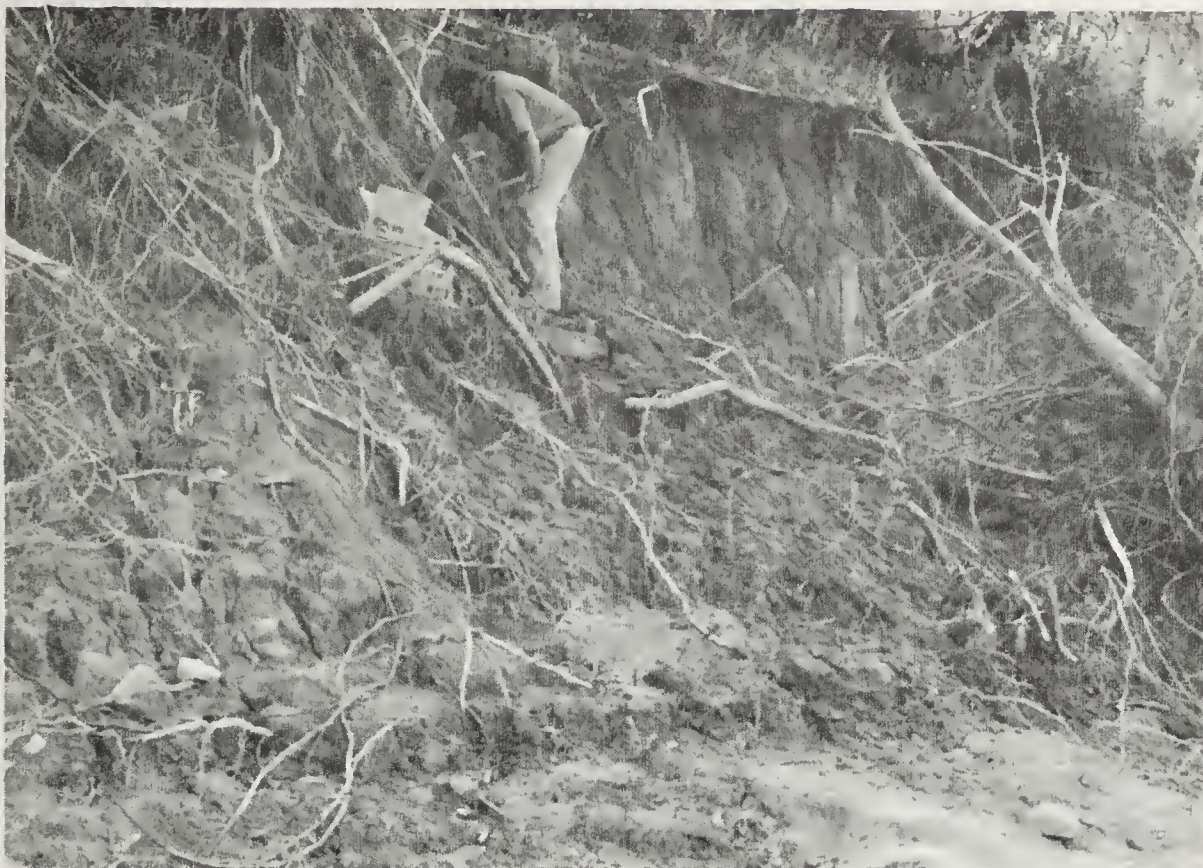
G

Sampling site within downstream portion of Glenn property. 5 May 1977

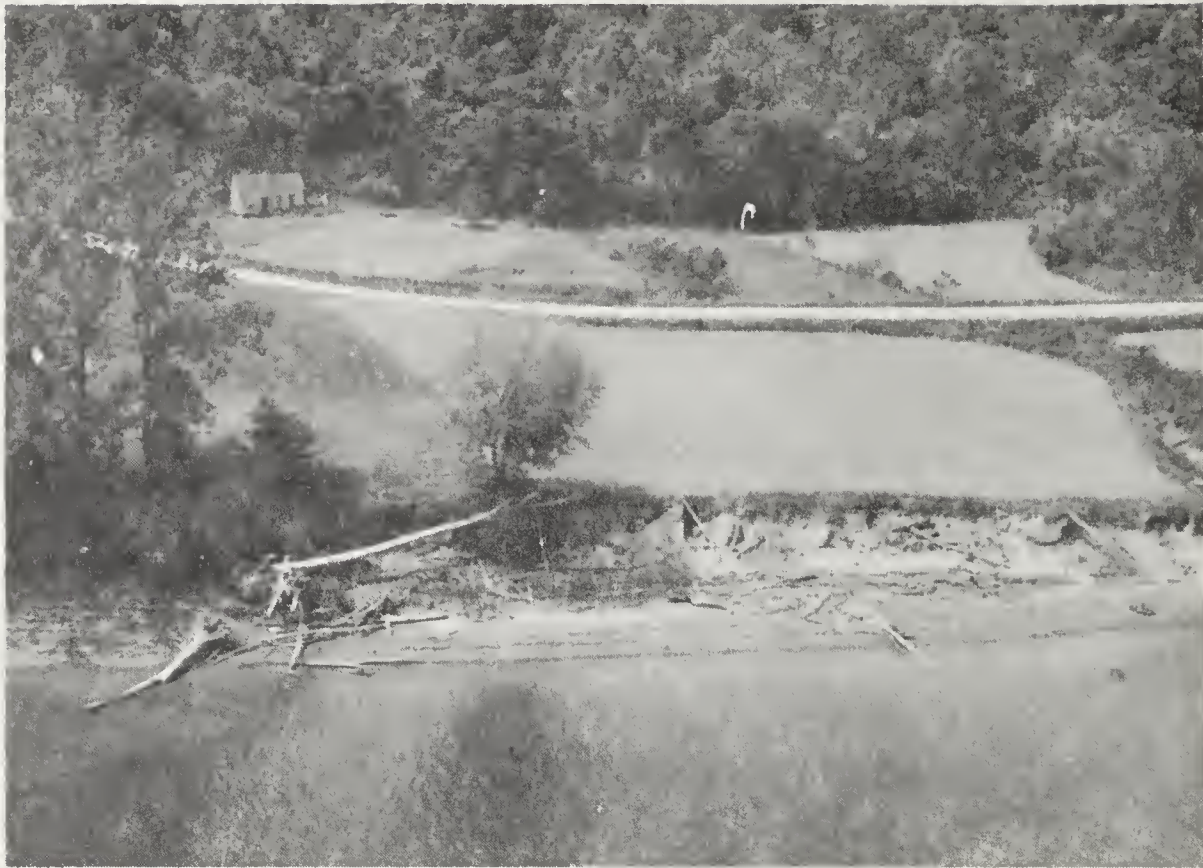
A

Bank area showing sample site. 23 May 1977

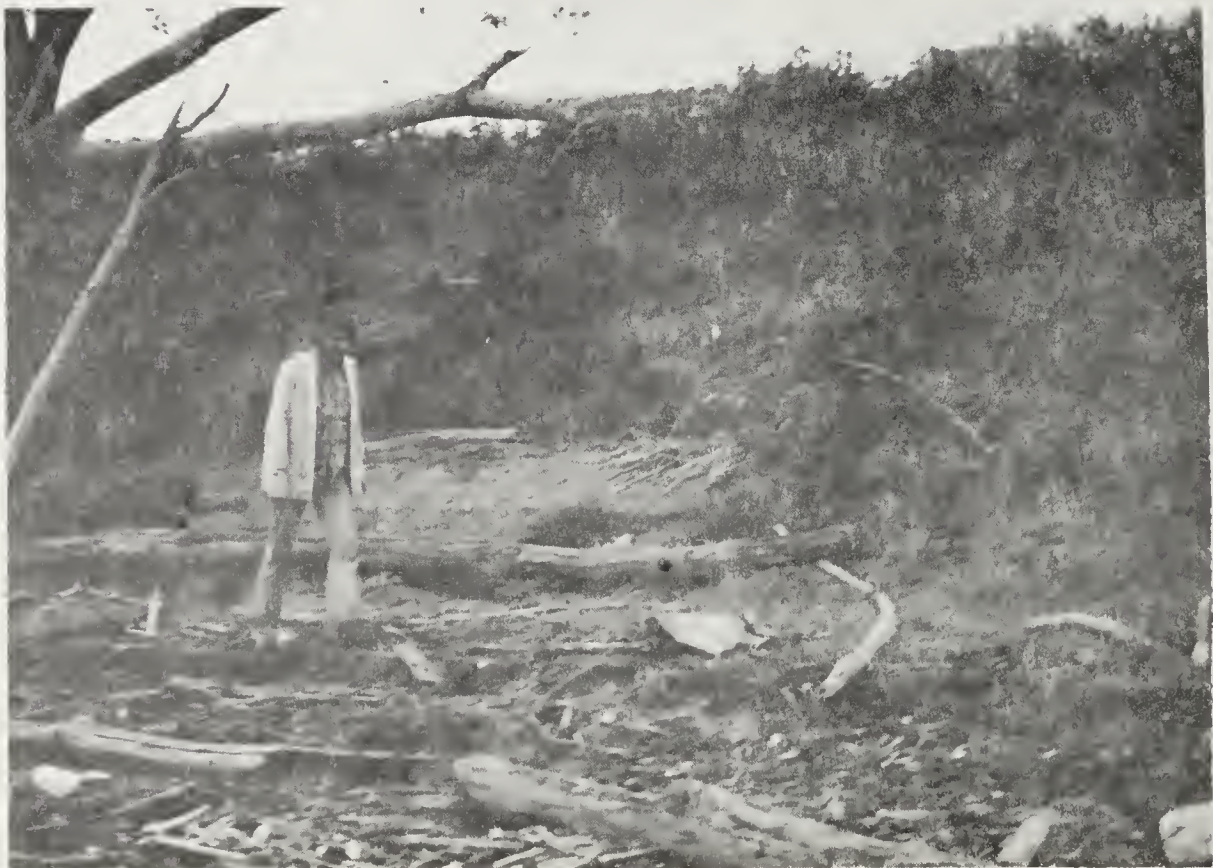
B

Bank area at sample site showing recent erosion and
drift deposition. 3 May 1977

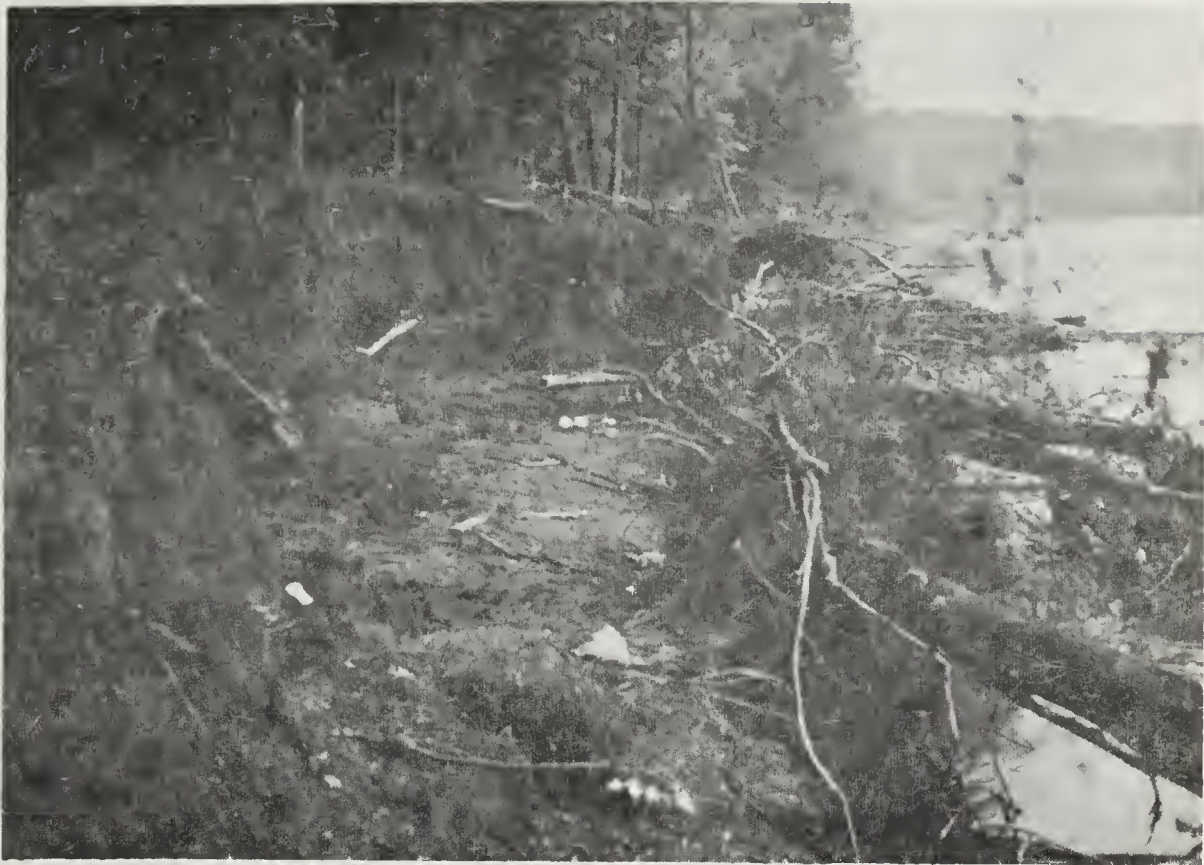
C

Bank erosion within upstream area of tract. Note
toppled trees. 3 May 1977

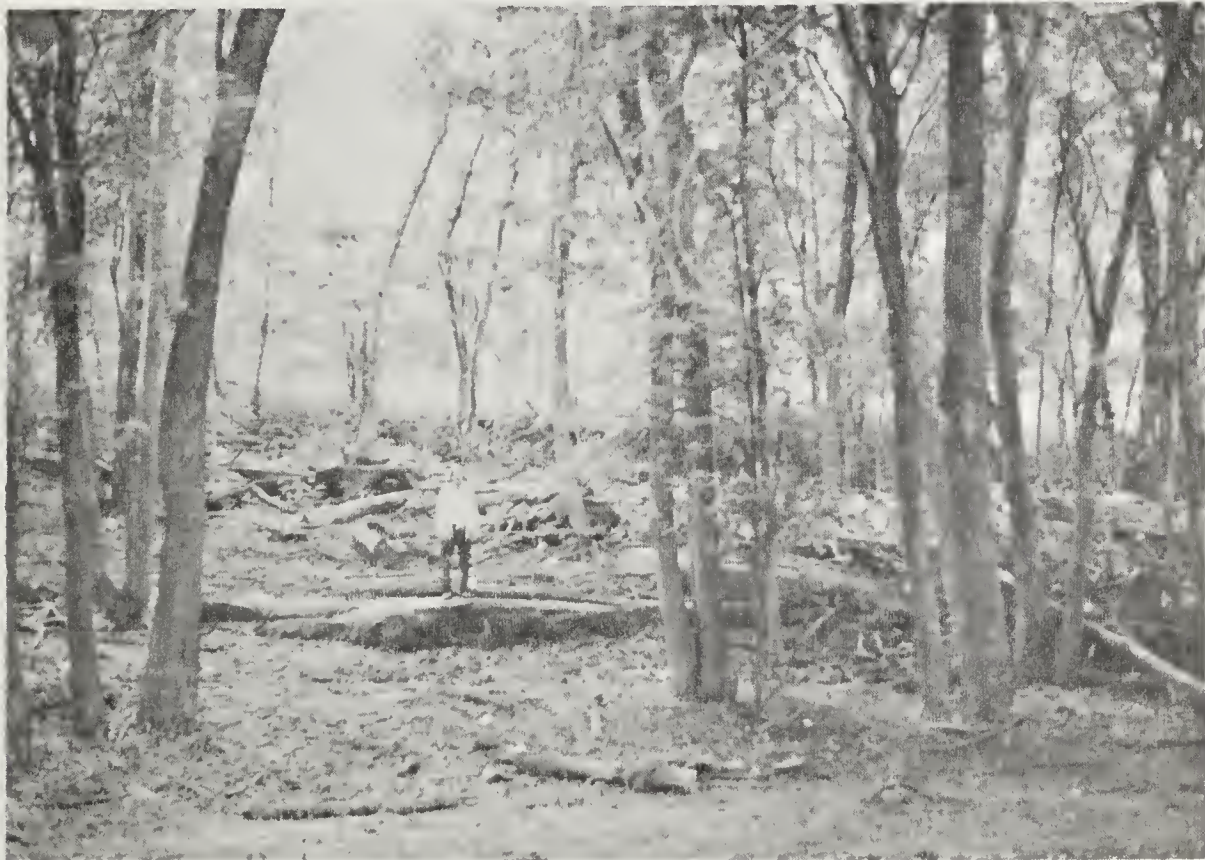
D

Bench area approximate to upstream boundary of tract.
Note rock outcrop. 3 May 1977

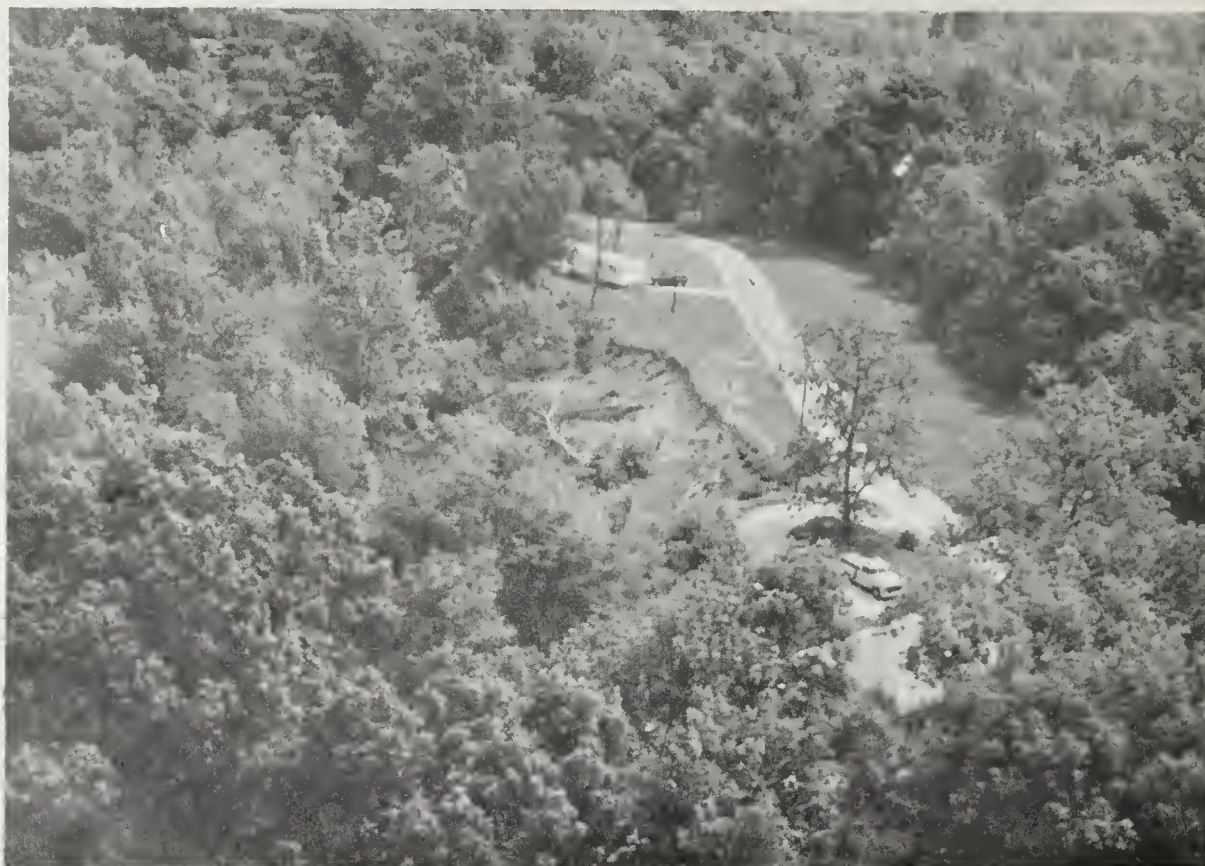
A

Slide area looking east, showing scarps.
23 May 1977

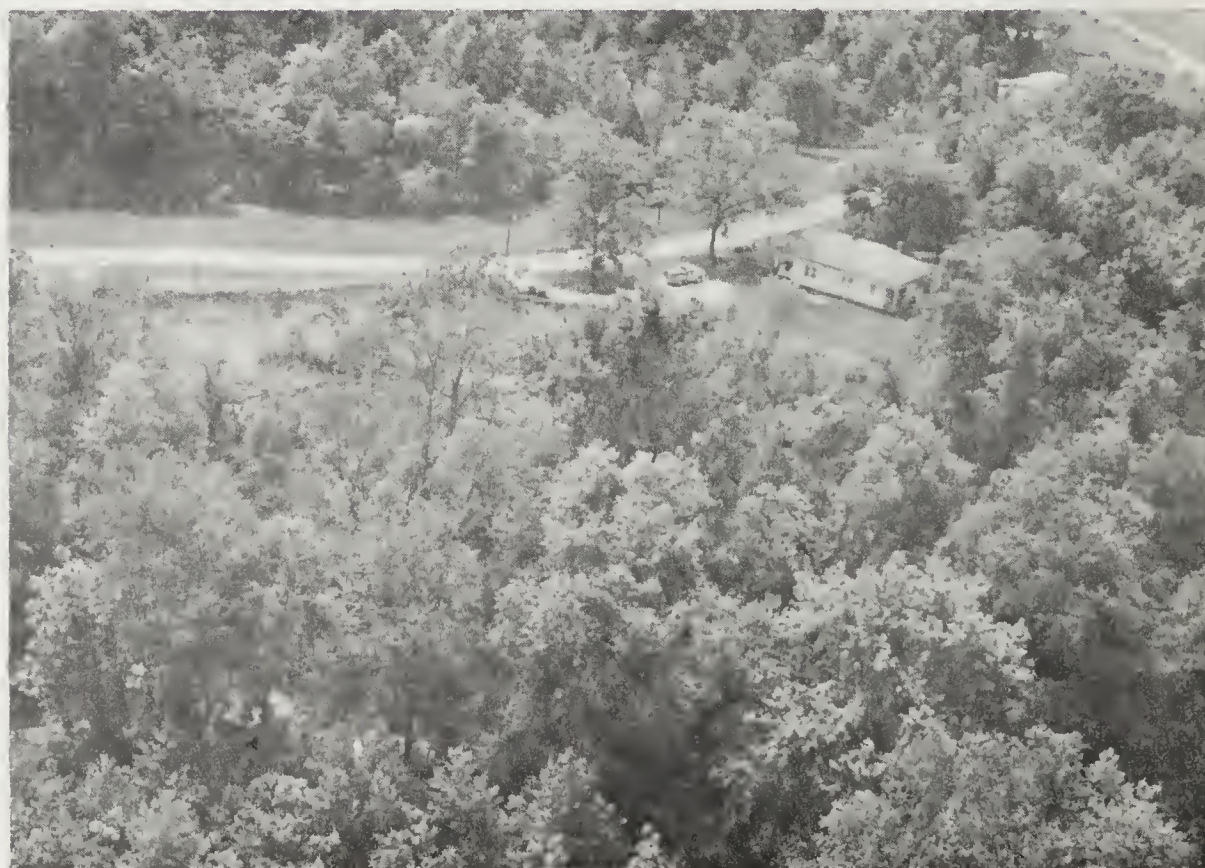
B

Slide area looking south, showing slumpage debris.
23 May 1977

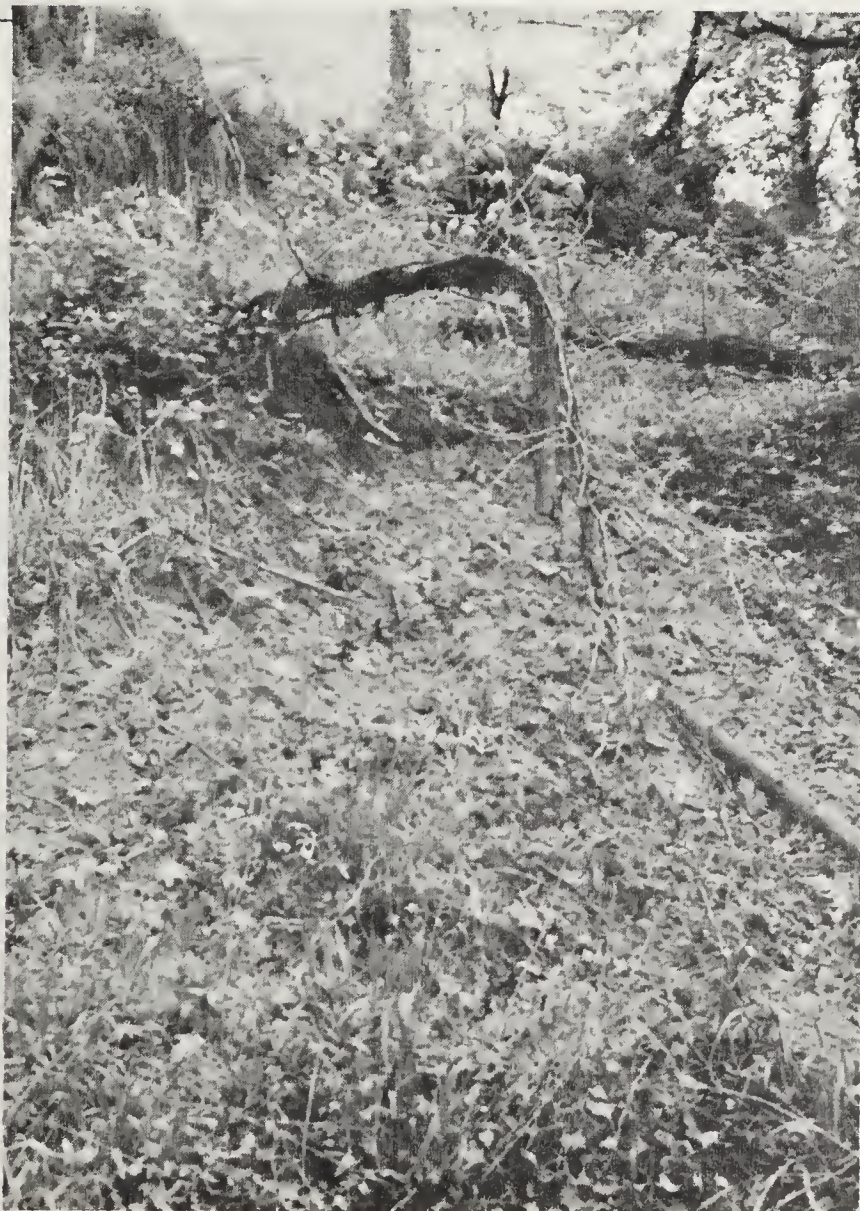
D

Area of slide below trailer at
sample site. 4 May 1977

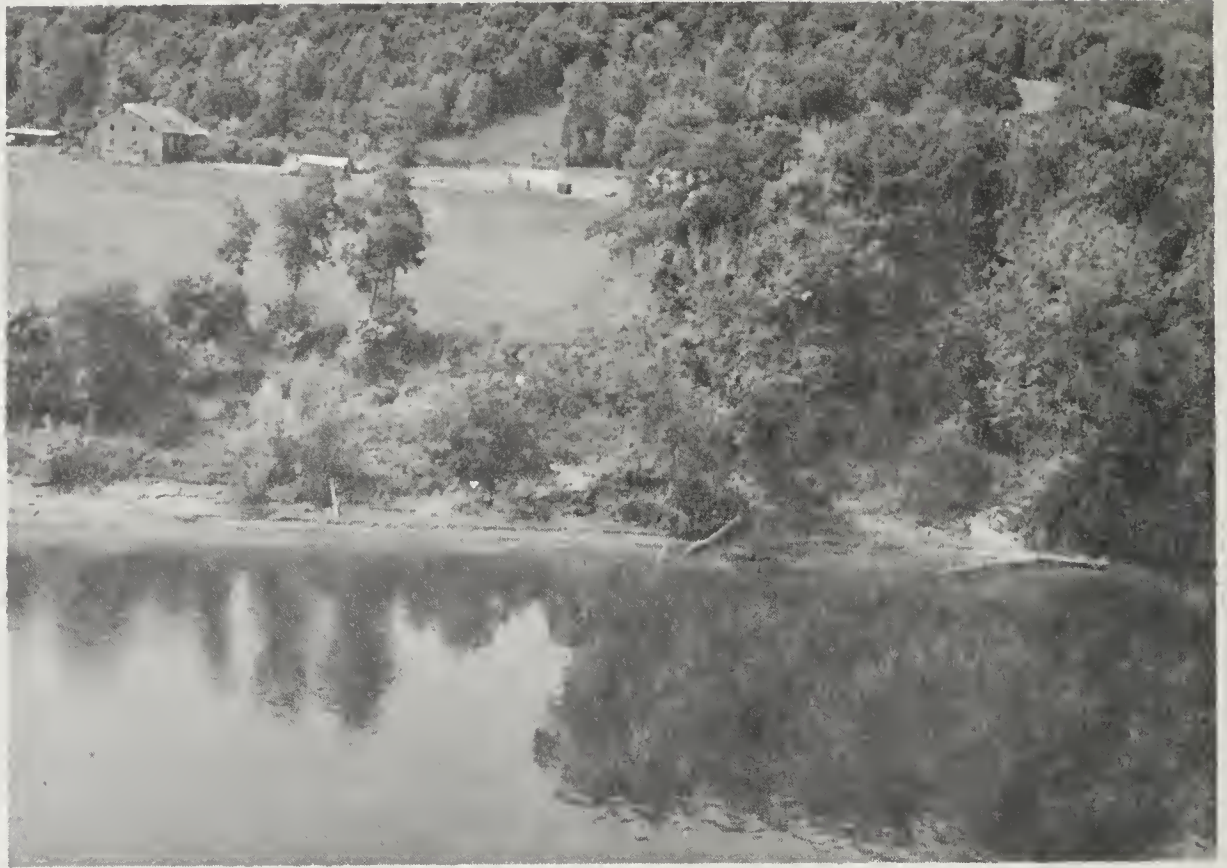
A

Reach of bank approximate to upstream boundary of tract
showing bank and stone placed in drainway. 23 May 1977

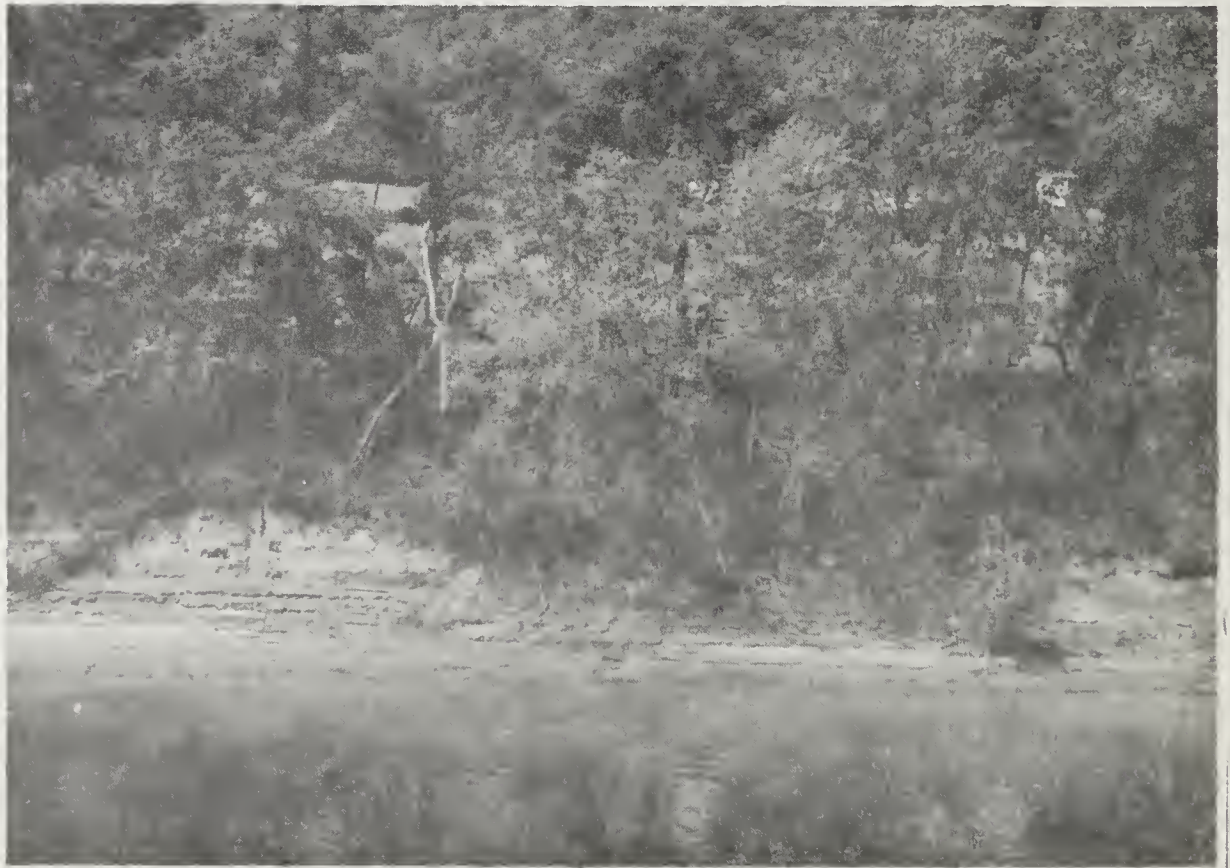
B

Reach of bank and sample site
23 May 1977

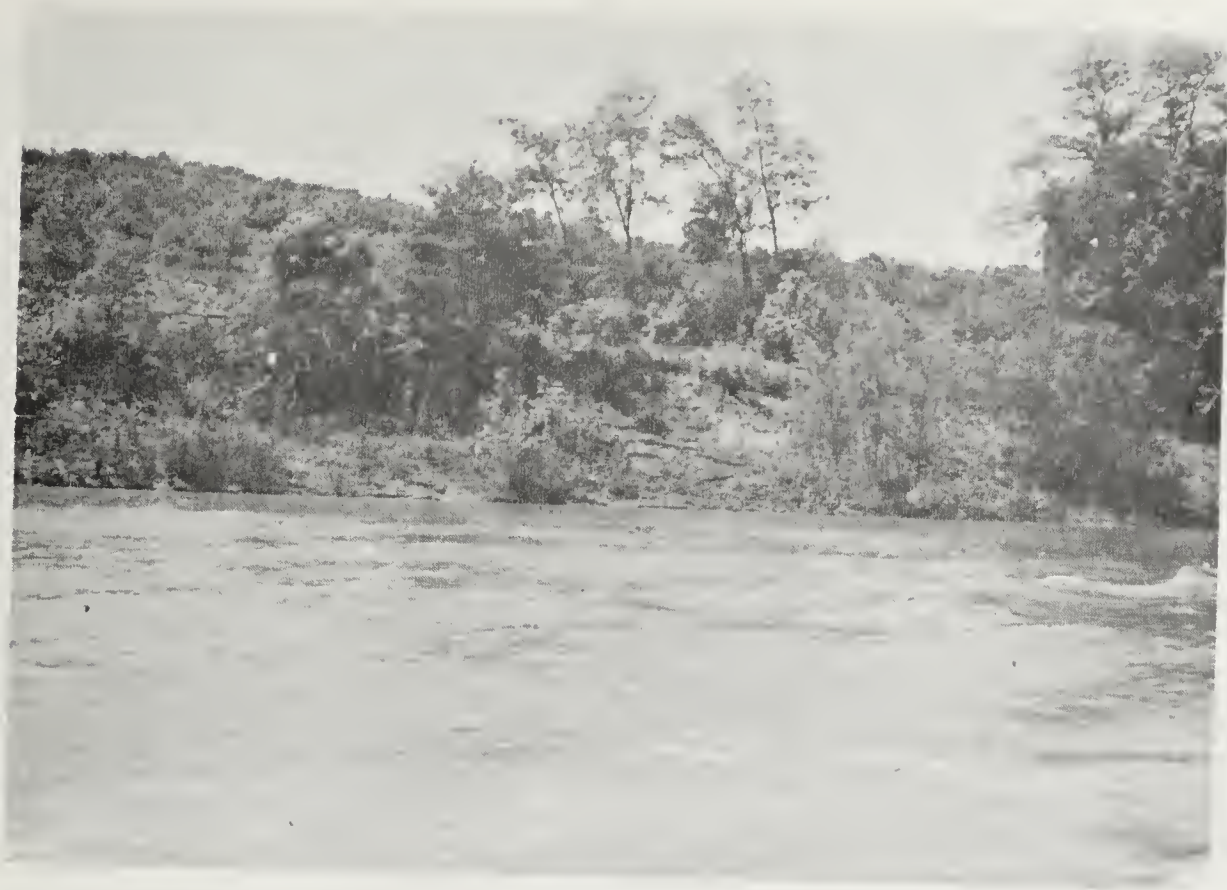
C

Reach of bank showing recent erosion in upper slope area. 9 May 1977
